Report on
Topographic and Bathymetric Survey of Reservoirs
for Water Resources Department, Govt. of Gujarat
at Saurashtra and Northern Gujarat Region, Gujarat
Machhu-1 Reservoir

OSaS/P34320/WRD/Saurashtra/Machhu-1/178b

| Document Title | | Topographic and Bathymetric Survey of Reservoirs for Water Resources Department, Govt. of Gujarat at Saurashtra and Northern Gujarat Region – Machhu-1 Reservoir | | | |

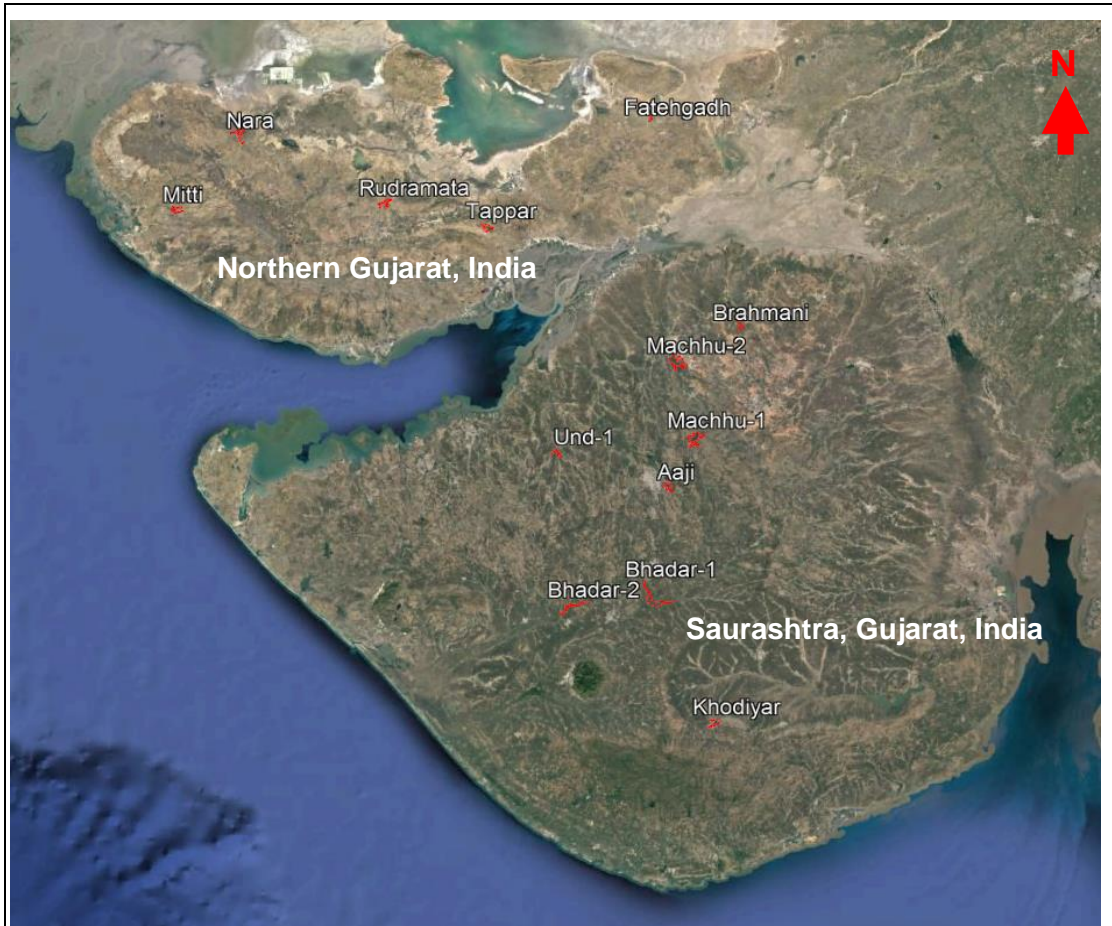
All the thirteen (13) reservoirs to be surveyed in the Saurashtra and Northern Gujarat region have been digitised on the Google Earth image and are shown in **Figure 1** (in red).

Figure 1: Overview of the thirteen reservoirs of Saurashtra and northern Gujarat region to be surveyed

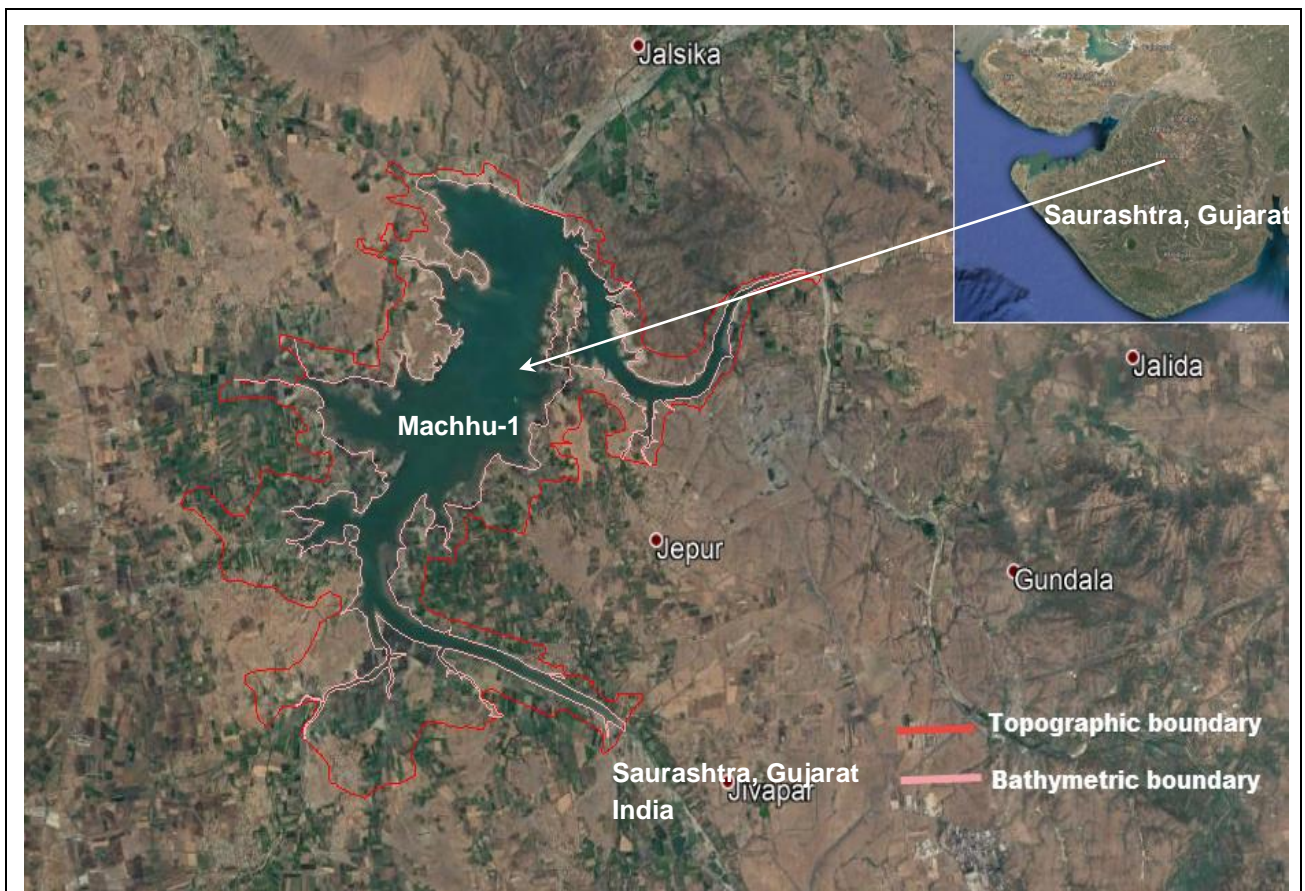
Figure 2: Surveyed areas (Topographic and Bathymetric) – Machhu-1 Reservoir

The surveyed area boundaries (both topographic and bathymetric) for Machhu-1 reservoir have been overlaid on the Google earth image shown in **Figure 2**.

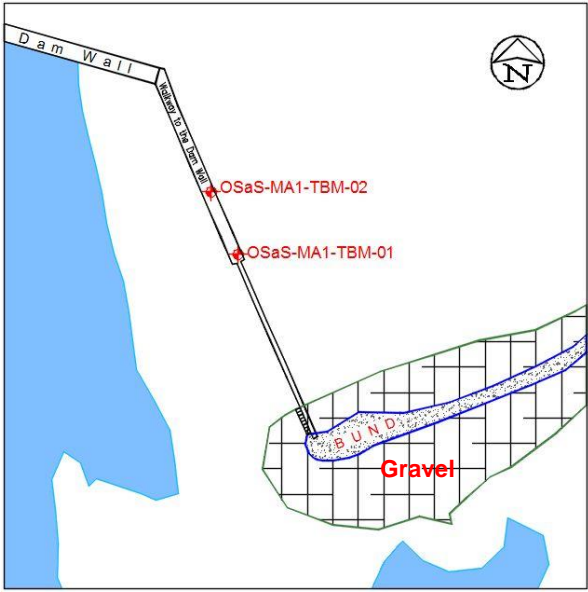
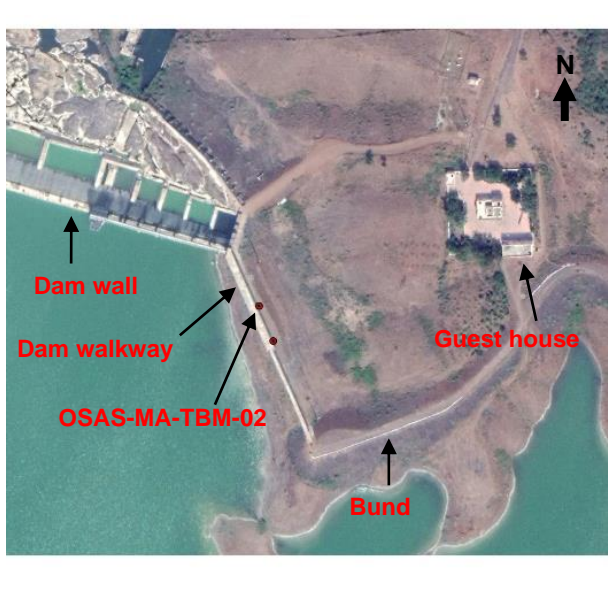
Figure 4: Details of OSaS-MA-TBM-02

| Station Description: | A square with a cross mark drawn inside it and text OSaS-MA-TBM-02 is written with yellow paint on the walkway to dam wall. | | |
| Access: | From the guest house at Machhu-1 dam head south-southeast for about 35m after which turn towards south-west and continue along the bund for about 135m to reach the dam walkway. Head towards north-west on the dam walkway for about 80m to reach the TBM location. | | |

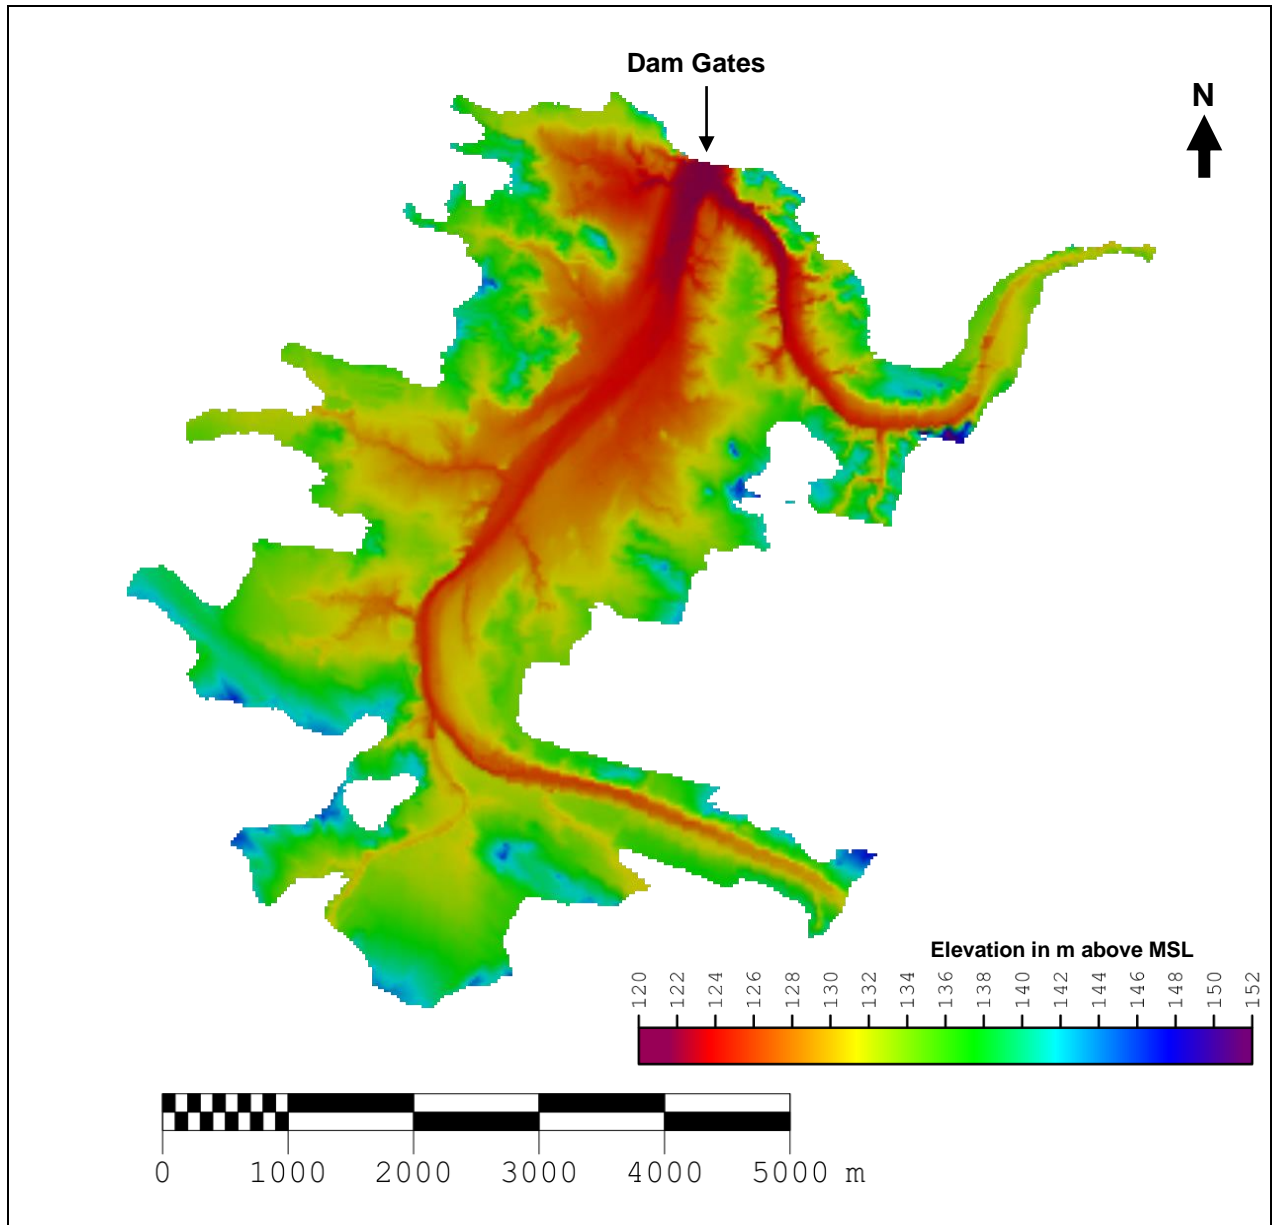
Figure 6: 2D image of Machhu-1 reservoir entire surveyed area

A minimum elevation of 121.3m and a maximum elevation of 135.3m was observed in the northern and north-western portion of the surveyed area respectively within the bathymetric section.

A general range of elevation change between 125.0m and 128.0m is observed within the bathymetric section for a major part of the reservoir. Moderate to steep slopes are generally observed all along the periphery of the reservoir, with the slopes becoming gentler moving away from the periphery towards the central portion of the reservoir. Occasionally, very steep gradients are observed in the surveyed area, mainly in the vicinity of and to the south of the dam gates.

A minimum elevation of 130.3m and a maximum elevation of 151.8m was observed in the south-southwestern and east-northeastern portions of the surveyed area respectively within the topographic section.

A general range of elevations between 132.0m and 136.0m is observed for a major part of the topographic surveyed area. The processed topographic data shows that the land is sloping with very gentle gradients from all the sides towards the reservoir area. Moderate to steep gradients are generally observed all along the reservoir banks where the topographic survey ends. Isolated to scattered areas, showing moderate variations in elevations compared to the surrounding topography are observed in the eastern, north-western and southern portions of the topographic surveyed area. Features like temples, houses, an island, cultivated lands, bunds, bushes, trees, ravines, roads and steps were observed within the topographic surveyed area.

Figure 6 shows a 2-dimensional image of the entire Machhu-1 surveyed reservoir area, generated using the gridded bathymetric and topographic data.

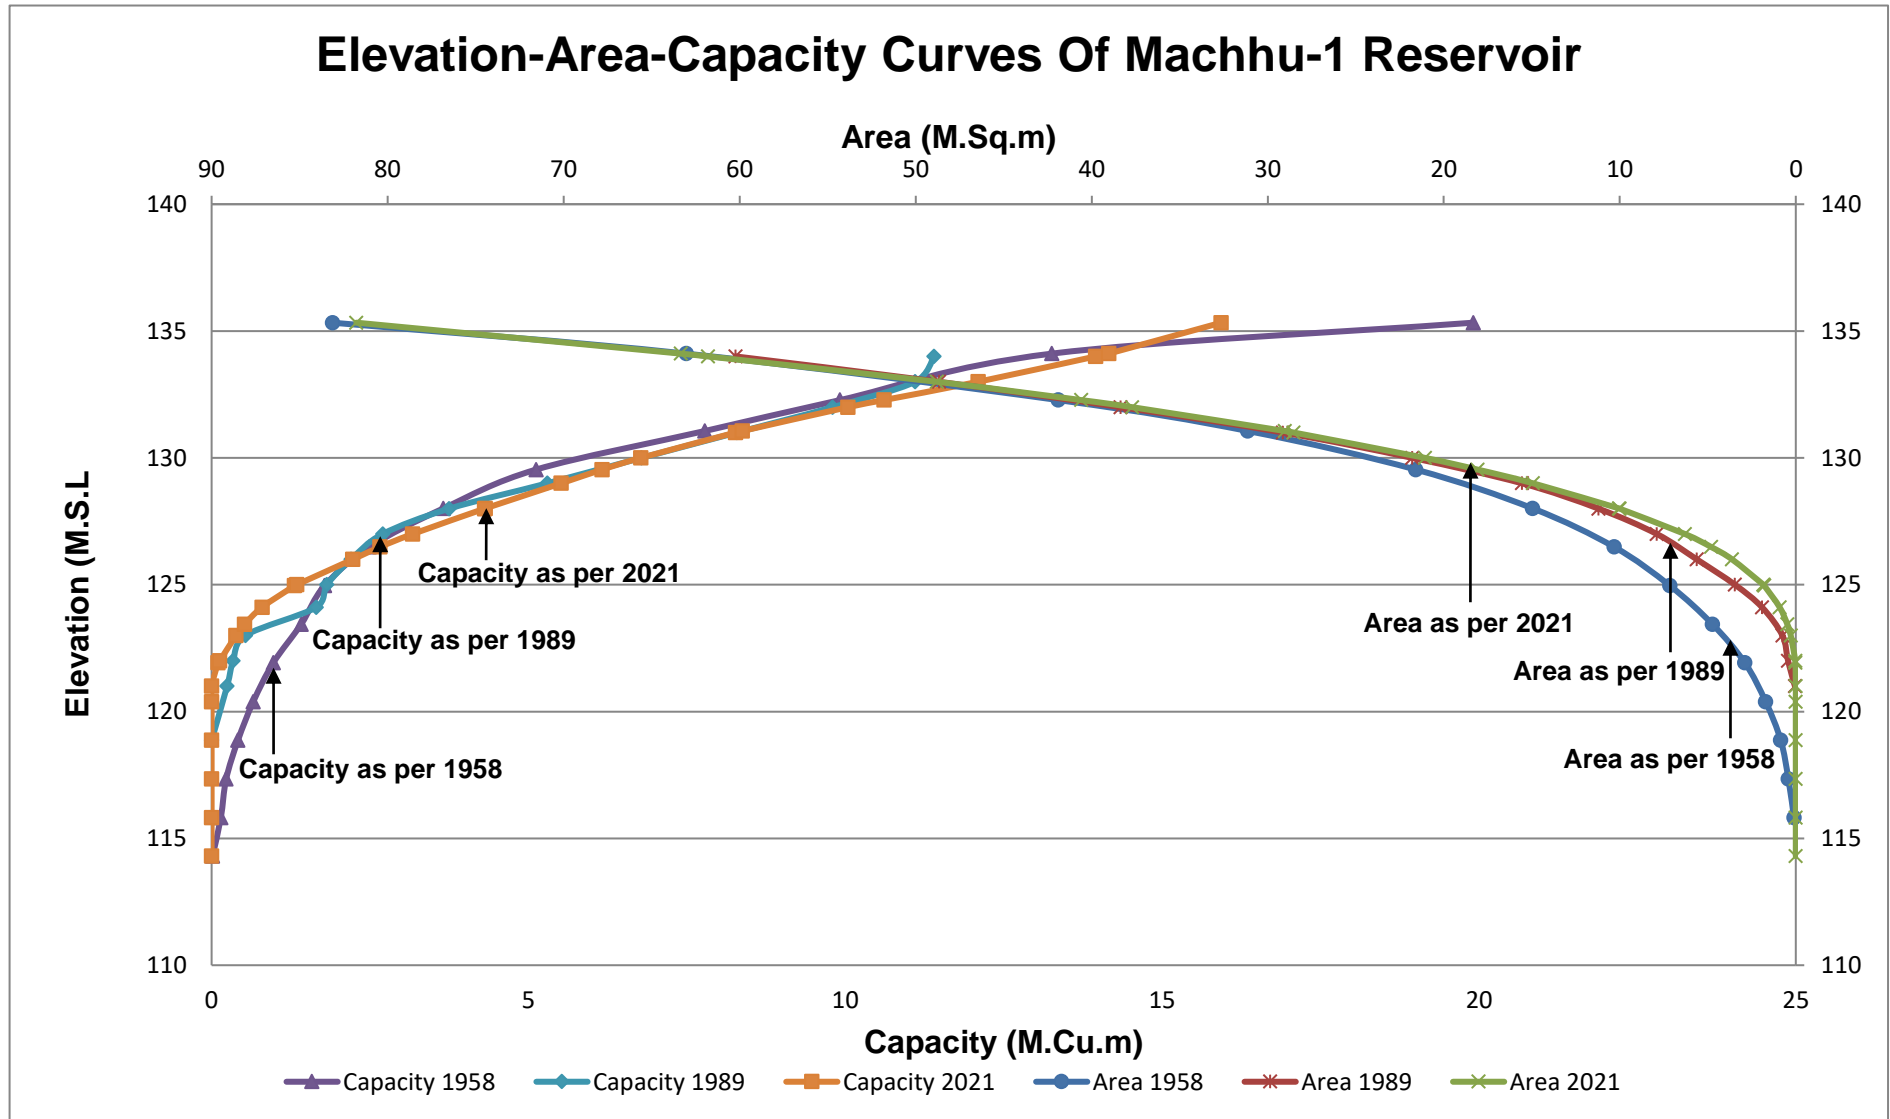
Figure 7: Elevation-Area-Capacity Curves (1958, 1989 and 2021))

The above data were used for the preparation of Elevation-Area-Capacity curves. **Figure 7** shows the Elevation-Area-Capacity curves of 2021 superimposed on the 1958 and 1989 Elevation-Area-Capacity curves.

On comparing the capacity and area data of the survey carried out in 1958 with that of 2021, it is observed that there is loss in reservoir capacity in 2021, except at the elevation 134.11m, where an increase of capacity (0.50%) is observed. The details of the area and capacities for the year 1958 and 2021 and the calculated rate of sedimentation and % loss of capacity at the particular elevations have been provided in **Table 9**. The elevation area capacity curves comparing the results of the surveys carried out in the year 1958, 1989 and 2021 are shown in **Figure 7**.

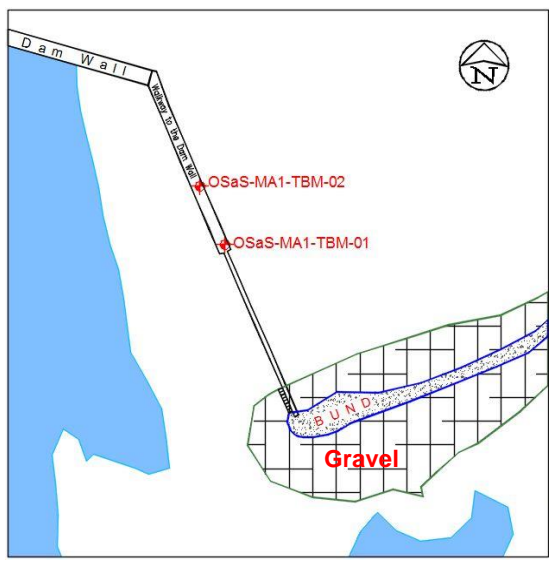
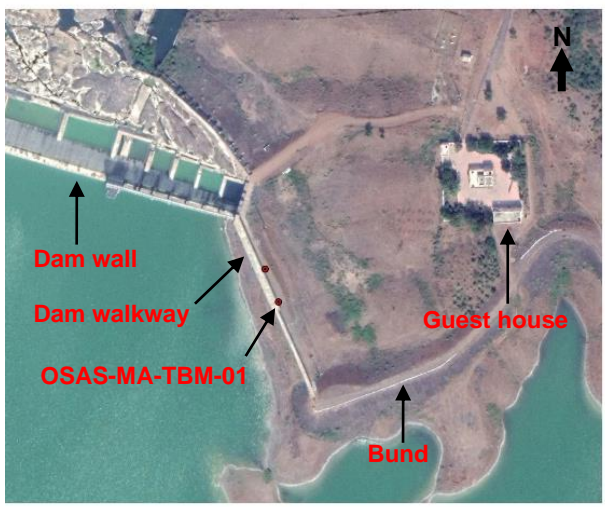
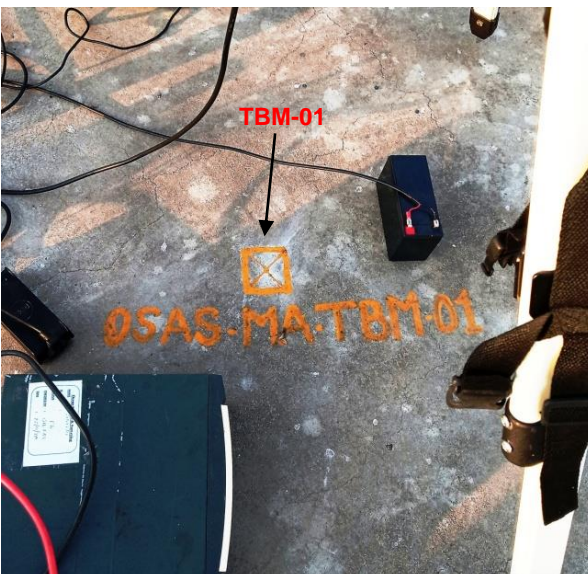
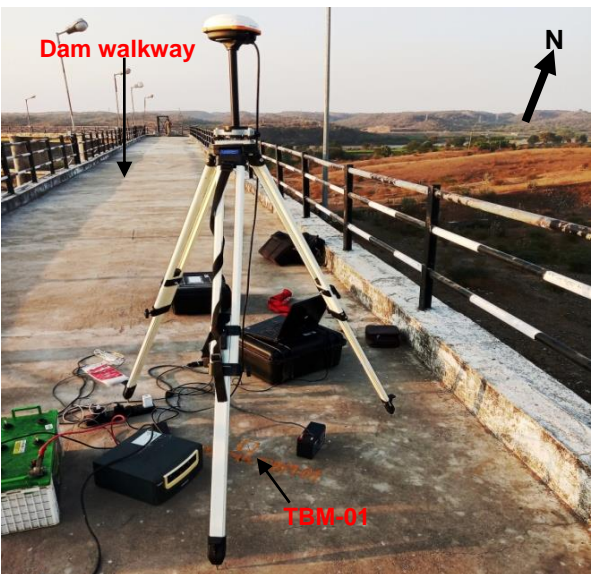
Table 1: Details of OSaS-MA-TBM-01

| Station Description: | A square with a cross mark drawn inside it and text OSaS-MA-TBM-01 is written with yellow paint on the walkway to the dam wall. | | |
| Access: | From the guest house at Machhu-1 dam head south-southeast for about 35m after which turn towards south-west and continue along the bund for about 135m to reach the dam walkway. Head towards north-west on the dam walkway for about 60m to reach the TBM location. | | |
